SERVICE INFORMATION LETTER

SIL - AR - 04 - IS28M2

(This Service Information Letter contains information for the flight and aircraft safety)
(Aeroclubul Romaniei is the Type Certificate Holder for the IS-28M2 motor gliders)

During the after-landing roll, at an IS-28M2 motor glider a landing gear folding had occurred, and the motor glider has stopped "on-belly" on the ground. The incident is presented in *The AIAS's Report No. I-20-03 /03.03.2020*.

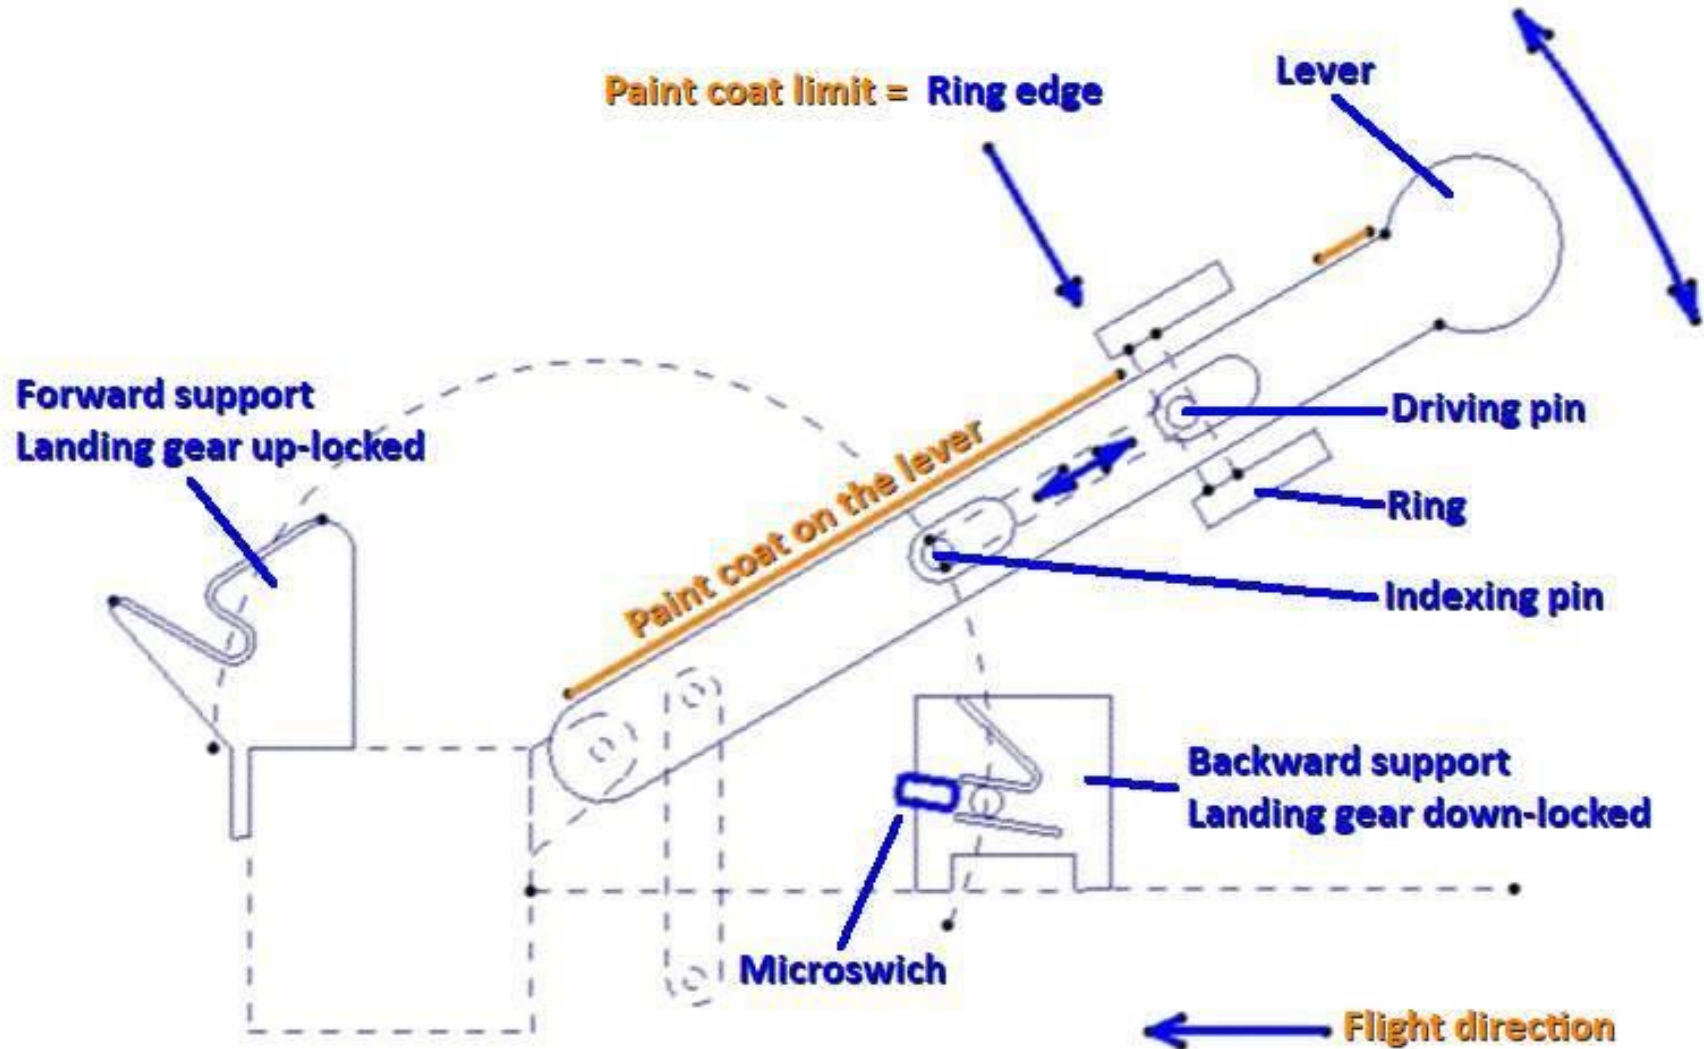
Fig. 1 – Gear Command Lever

See *Fig.1 – Gear Command Lever* and the *AFMM*.

- II. Place the lever on a intermediate position and let it free.
The lateral driving-pins and the lateral indexing-pins must touch simultaneously the ends of the slots in which they slide, in the directions in which they are pressed by the spring.

- IV. With the lever free on the intermediate position, check out the possibility of notice a correct indexing. The limit of the paint coating on the lever must coincide with the edge of the ring which slides above the lever.

- V. Push the lever forwards until it indexes in the forward-support (gear-up-locked position).
The locking must be complete, the lateral indexing pins of the lever must get into the left and right guides of the forward-support, as far as the guides allow.

- VI. Pull the lever backwards until it indexes in the backward-support (gear-down-locked position).
The locking must be complete, the lateral indexing pins of the lever must get into the left and right guides of the backward-support, as far as the lever slots allow.
In this position, perform a visual check to confirm the correct locking (see §6.a.IV).

- I. The landing gear retraction lever shall be repeatedly placed: on a intermediate position, on the gear-down-locked position and on the gear-retracted-locked position. At these positions, the following checks and adjustments must be performed.

- III. Keep the lever on the intermediate position. For both, when pulling and when releasing the driving-pins, the movement of the moving parts must be smooth, without getting stuck. The spring must firmly push the pins to the end of the respective lever slot.

- VII. With the command lever on the gear-down-locked position, check the over passing of the dead spot centre during the landing gear extension.
At each landing leg the measurement of $12 \pm 1\text{mm}$ must be obtained (as per *AFMM* page 4.10).

- VIII. With the command lever on the gear-down-locked position, check the motion clearance between the landing gear retraction system parts, by manually pulling on each landing leg, to the left, to the right, forwards and backwards.

There must be no free-motion detected within the whole control system.
